Service Bulletin

Product Code(s) Affected: 1M8550/1M8550R
Product Name: Auto Syringe AS50 Infusion Pump
Usage: (X) Internal / (X) External

Title: Auto Syringe AS50 Infusion Pump Rear Case Inspection and Replacement

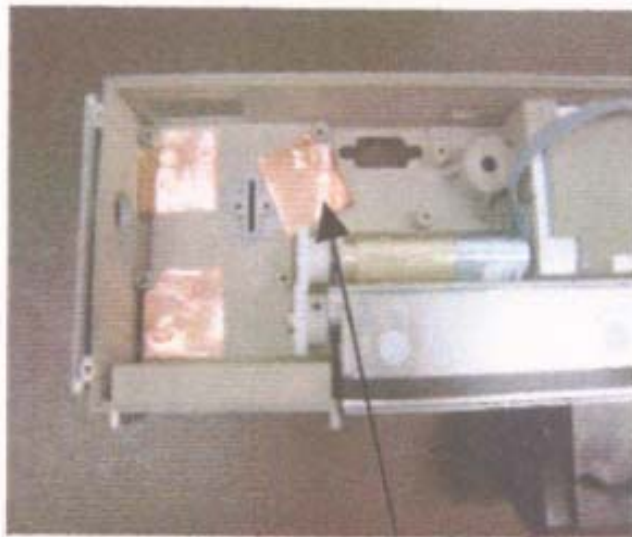
Non-Conforming Part

The Rear Case assemblies were manufactured with ESD grounding squares that may have been manufactured with the adhesive applied to the incorrect side resulting in exposure of the conductive surface of the I/O board. Pumps that have been serviced or repaired with these components could short circuit resulting in a loss of audio and/or interruption of therapy.

Non-conforming
ESD Squares are
evident by Copper
Foil face up.

If the grounding squares are non-conforming, remove the pump from service, complete the Customer Inspection Documentation Form, and return the form to Baxter within **30 days** of receipt of this service bulletin.

-
- 5.4 Upon receipt of replacement rear case assemblies from Baxter, verify the replacement rear case assembly grounding squares are correctly assembled per the illustrations below.
 - 5.5 Follow the instructions in the service manual to replace the non-conforming rear case assemblies.
 - 5.6 Mark "6" on the device configuration label, located inside the battery cover.
 - 5.7 Perform required Calibration, Functional and Final Testing prior to placing device back into service.
